Smoke and Dye-Water Observation Summary

Western Run Pilot Project - Baltimore Maryland

INSPECTION REPORT

| STREET: DEVONSHIRE DR. 96 B 5 | MAP #1: 1 | MH: 1521105 |

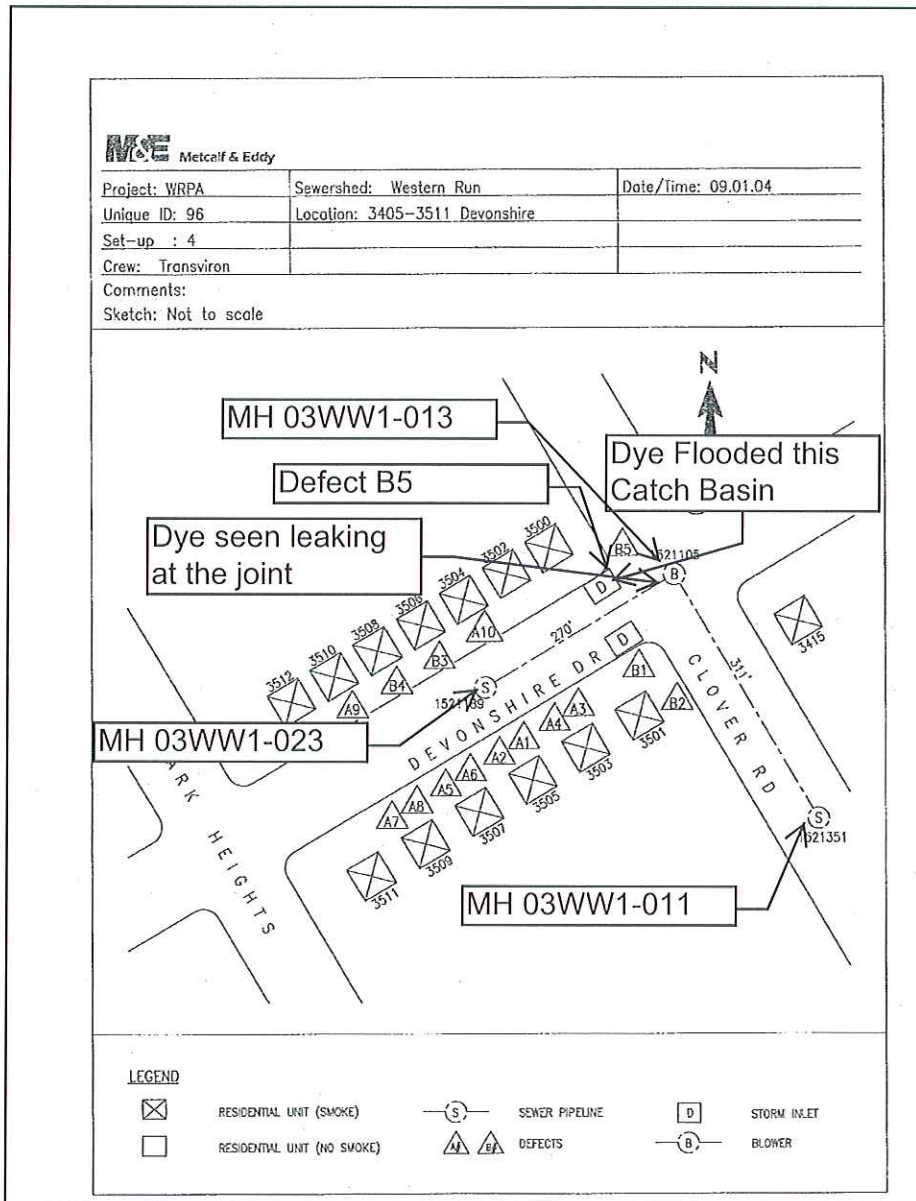
Sketch No: 96

Additional Comments: STORM M.H. IS BLOCKED UP WITH
DEBRIS

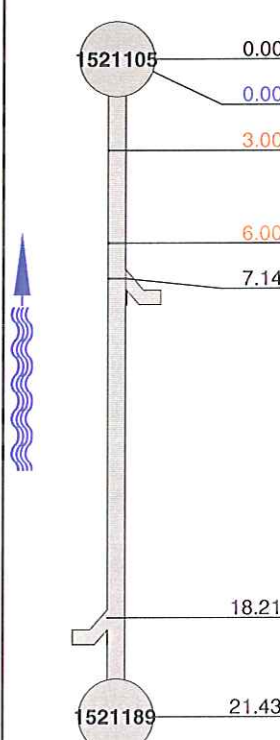
| 1:75 | DIST | OBSERVATION | RATE | VCR # | PH |
|--|---|---|---|---|---|
| | 0.00 | inspection begins at downstream manhole, 1521105 | 0 | 00:00:00 | |
| | 0.00 | Infiltration Seeping at joint at 04 o'clock | 2 | 00:00:29 | 2a |
| | 3.00 | Infiltration Running at joint from 04 to 08 o'clock | 3 | 00:02:07 | 3a, b |
| | 6.00 | Infiltration Running at joint at 08 o'clock | 3 | 00:02:31 | |
| | 21.43 | inspection ends, NO MORE DYE TEST LEAKS SEEN. | 0 | 00:04:27 | 7a |
